Case study Subsea asset 3D modelling of an Offshore Wind Farm

Enabling data to drive the future of marine robotics

Rovco, a leading provider of ROV and hydrographic services, contracted by a Major Energy operator, undertook a baseline asset integrity survey at a newly constructed Offshore Wind Farm in the UK.

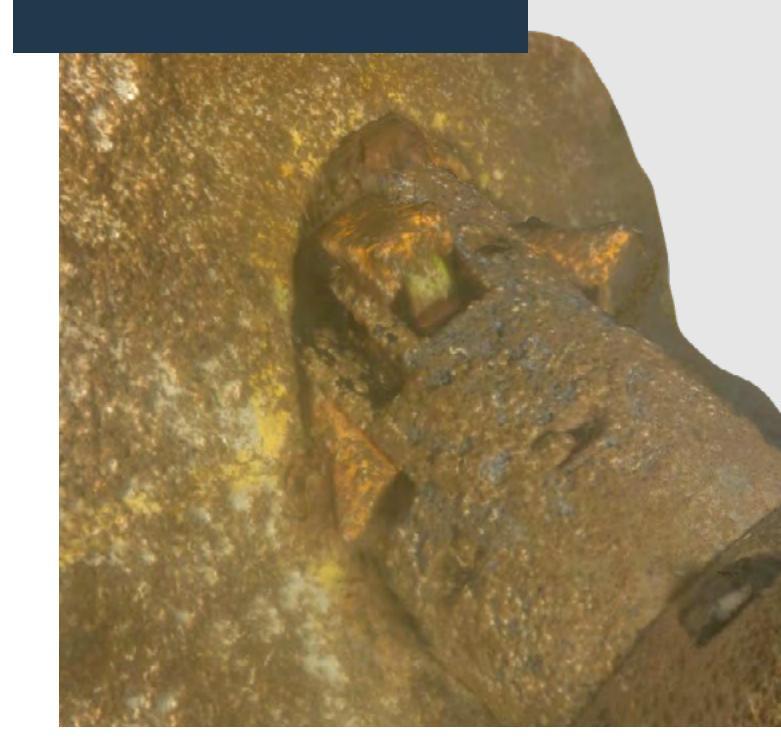
3D model of critical component

Post-processing the video data in Rovco's Headquarters meant their team could create the highest quality photogrammetry models from the data collected by SubSLAM®, focusing on the key subsea components as specified by the end-client. The 3D models provided an ideal baseline to encounter changes moving forward, with overlay modelling in subsequent years. Filters out suspended particles to focus on robust feature tracking

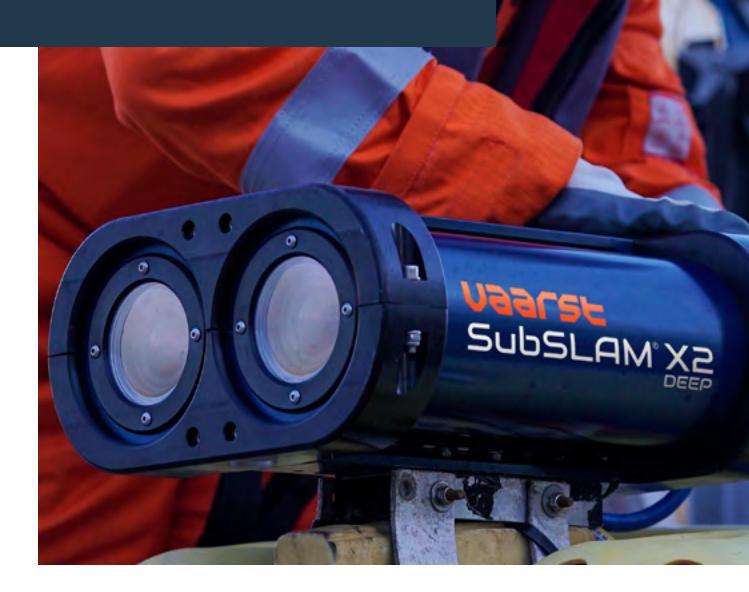
Millimetre accurate 3D of CPS Systems
